Augusta Exit 113 - Route 3 to Route 27 Traffic Study Natural Resource Existing Conditions Technical Memo Report

PIN 17592.00

Introduction

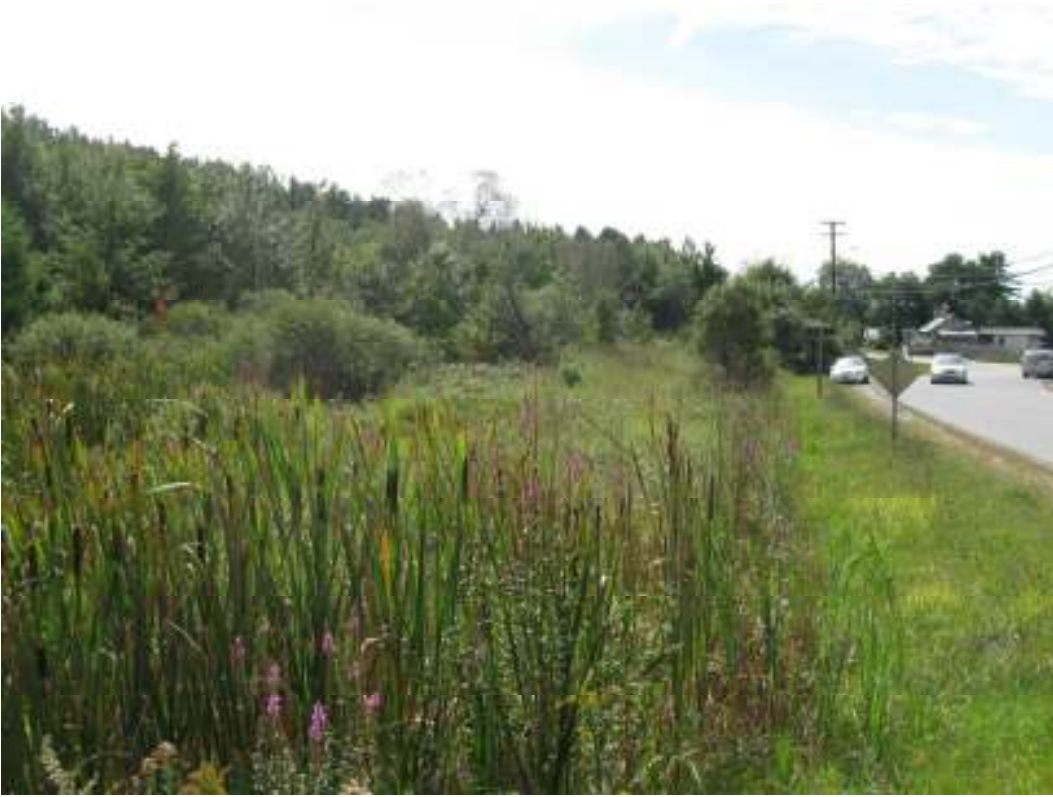
Functional assessment:													
1. Town: Augusta			2. Route: Exit 112-113 study- Old Belgrade RD				3. PIN: 17592.00						
4. Wetland ID: 112-1			5. Cowardin Class: PSS				6. Stationing/Location:						
7. Dominant Vegetation: Alders, Black ash. Cattail							8. Wetland Morphology: Discharging hill side						
8a. NEIWPCC Soils Criteria: No samples taken													
9. Notes: This wetland drains a field and discharges out of a steep hill side. The water runs overland and is impounded by Route 27													
10. FVA Table: impacted area													
F/V	GRD	FFA	AH	STR	NTR	PE	SSS	WH	REC	ESV	U/H	VQA	ES
Occurs	X			x									
Principal	X												
Impacted area notes:													
Whole wetland notes:													
11. Is this wetland part of larger complex: Yes, this flows into a low point in the landscape, and is part of a complex that extends across Route 27.

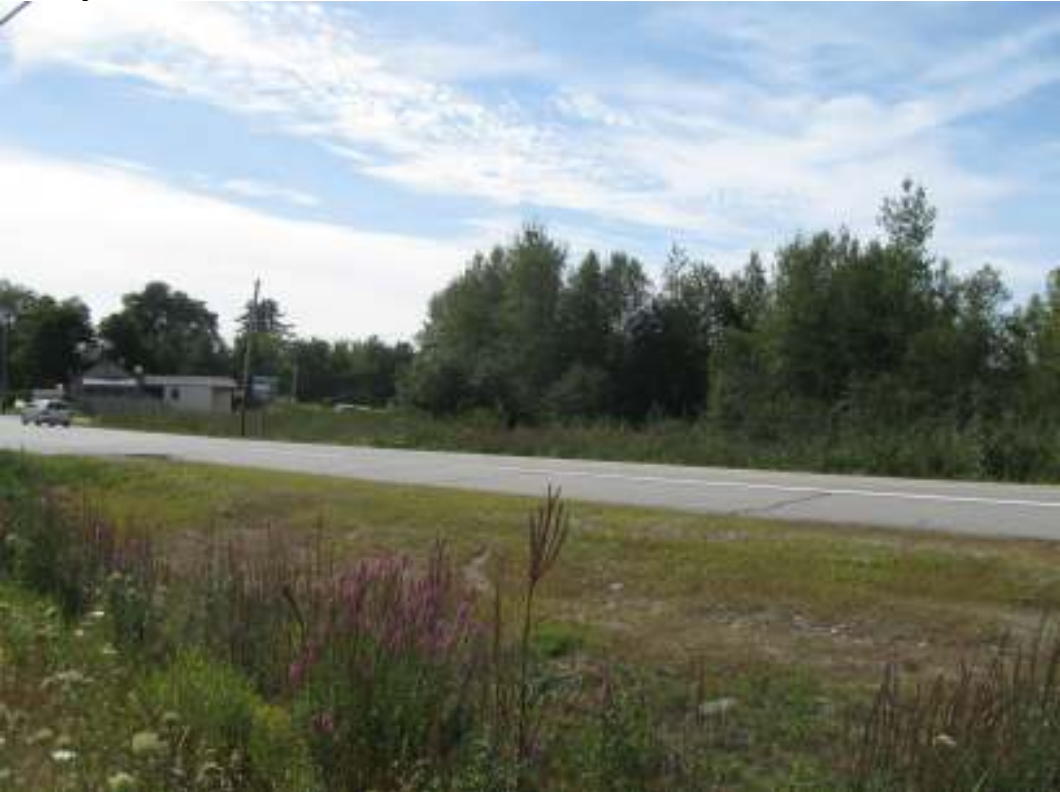
Functional assessment:													
1. Town: Augusta				2. Route: Exit 112-113 study- Old Belgrade RD				3. PIN: 17592.00					
4. Wetland ID: 112-2				5. Cowardin Class: PEM/SS				6. Stationing/Location:					
7. Dominant Vegetation: Cattail, Purple Loosestrife, Willows, Alders,								8. Wetland Morphology: Basin wetland at toe of large hill					
8a. NEIWPCC Soils Criteria: No soils taken													
9. Notes:													
10. FVA Table: impacted area.													
F/V	GRD	FFA	AH	STR	NTR	PE	SSS	WH	REC	ESV	U/H	VQA	ES
Occurs		x			x								
Principal					x								
Impacted area notes: This is a basin wetland that is adjacent to a highway. It collects runoff from upstream and from the highway.													
11. Is this wetland part of larger complex: It is along a topographical drainage													
12. Impact Notes/Photos

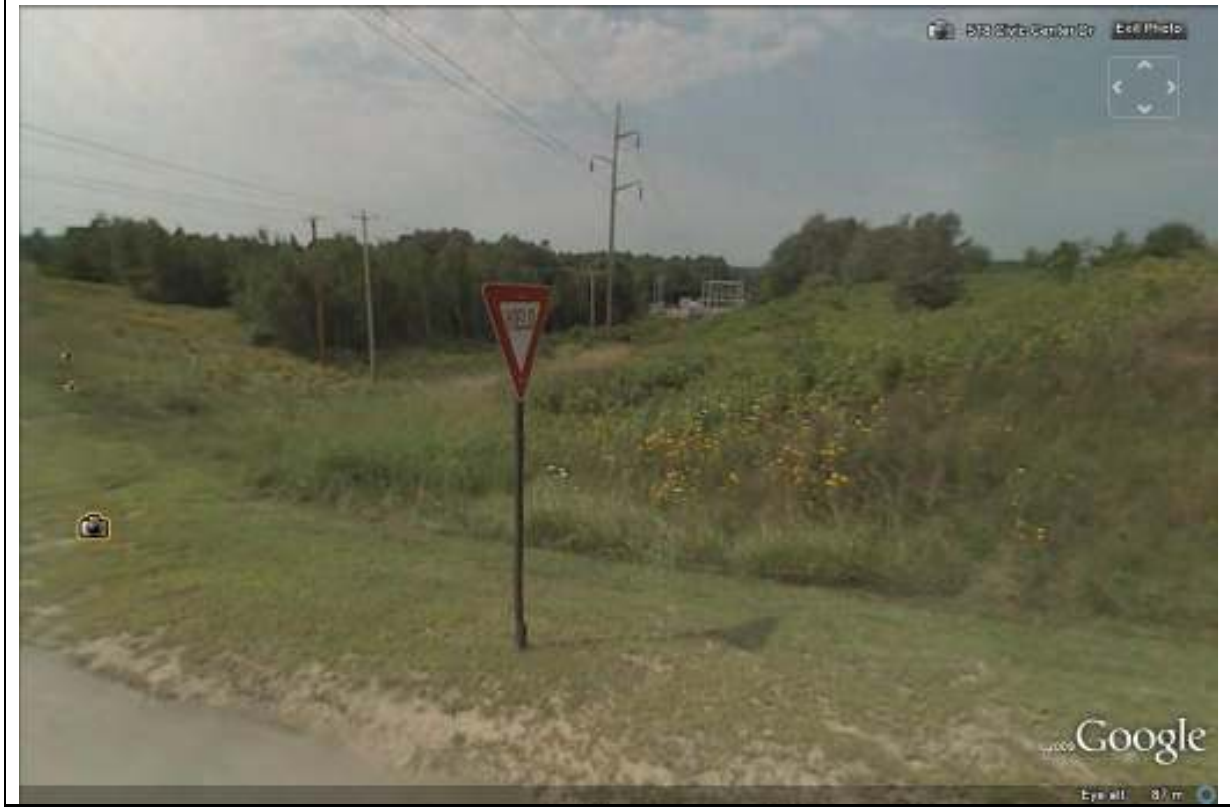
Functional assessment:													
1. Town: Augusta			2. Route: Exit 112-113 study- Old Belgrade RD				3. PIN: 17592.00						
4. Wetland ID: 112-3			5. Cowardin Class: PSS				6. Stationing/Location:						
7. Dominant Vegetation: Grasses- Not sampled							8. Wetland Morphology: Discharging slope						
8a. NEIWPC Soil Criteria: Not Sampled													
9. Notes: Review and delineation based on mapping-													
10. FVA Table: impacted area													
F/V	GRD	FFA	AH	STR	NTR	PE	SSS	WH	REC	ESV	U/H	VQA	ES
Occurs				X									
Principal				X									
<p>Impacted area notes: Sediment toxicant functions because it is a broad vegetated swale down slope of a highway</p> <p>Whole wetland notes:</p>													
11. Is this wetland part of larger complex:

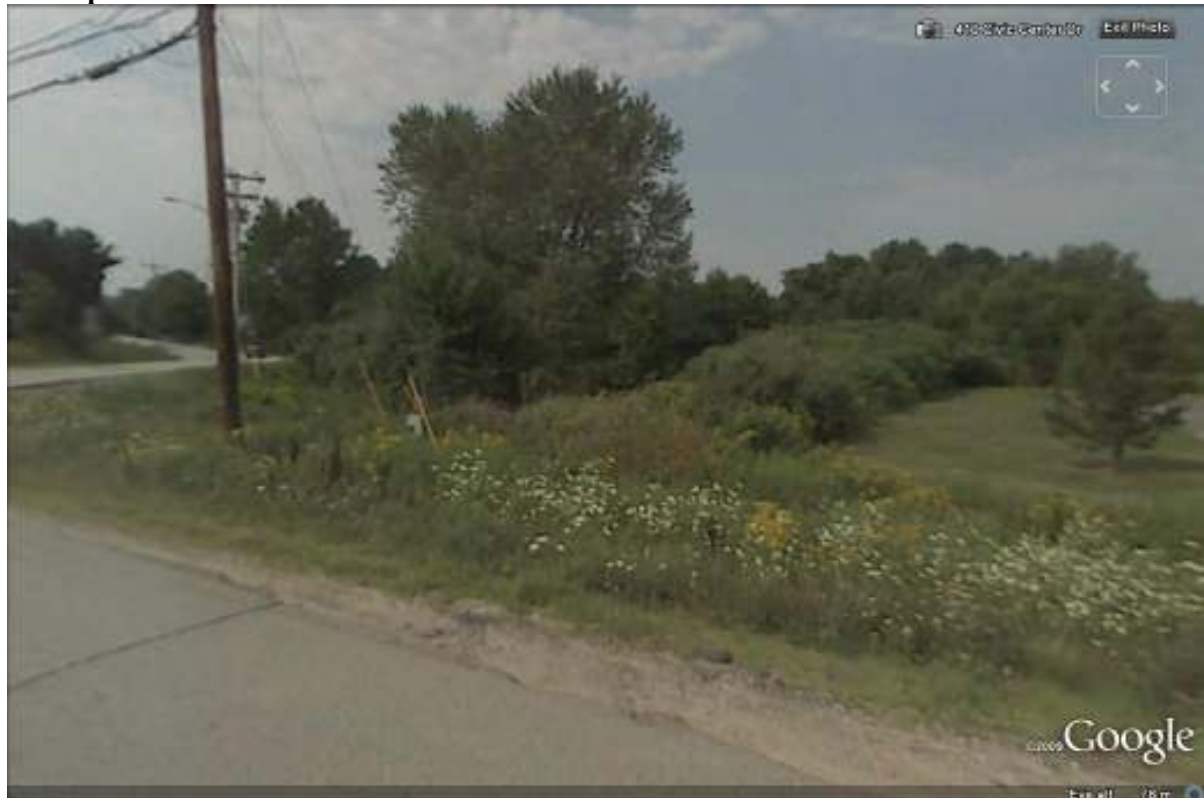
12. Impact Notes/Photos 112-4

1. Town: Augusta	2. Route: Exit 112-113 study- Old Belgrade RD	3. PIN: 17592.00											
4. Wetland ID: 112-4; 112-5	5. Cowardin Class: PEM	6. Stationing/Location:											
7. Dominant Vegetation: Cattails. Bulrush. Purple loosestrife		8. Wetland Morphology: Drainage swale											
8a. NEIWPCC Soils Criteria: No soils taken													
9. Notes: This wetland is a drainage swale at the base of a slope. It is also surrounded by developed properties.													
10. FVA Table: impacted area													
	GRD	FFA	AH	STR	NTR	PE	SSS	WH	REC	ESV	U/H	VQA	ES
Occurs		X		X									
Principal		X											
<p>Impacted area notes:</p> <p>The wetland collects surface run off from surrounding uplands. 112-4 and 112-5 are connected by a drainage culvert under Route 27. The wetlands also retain sediments from the adjacent Route 27.</p>

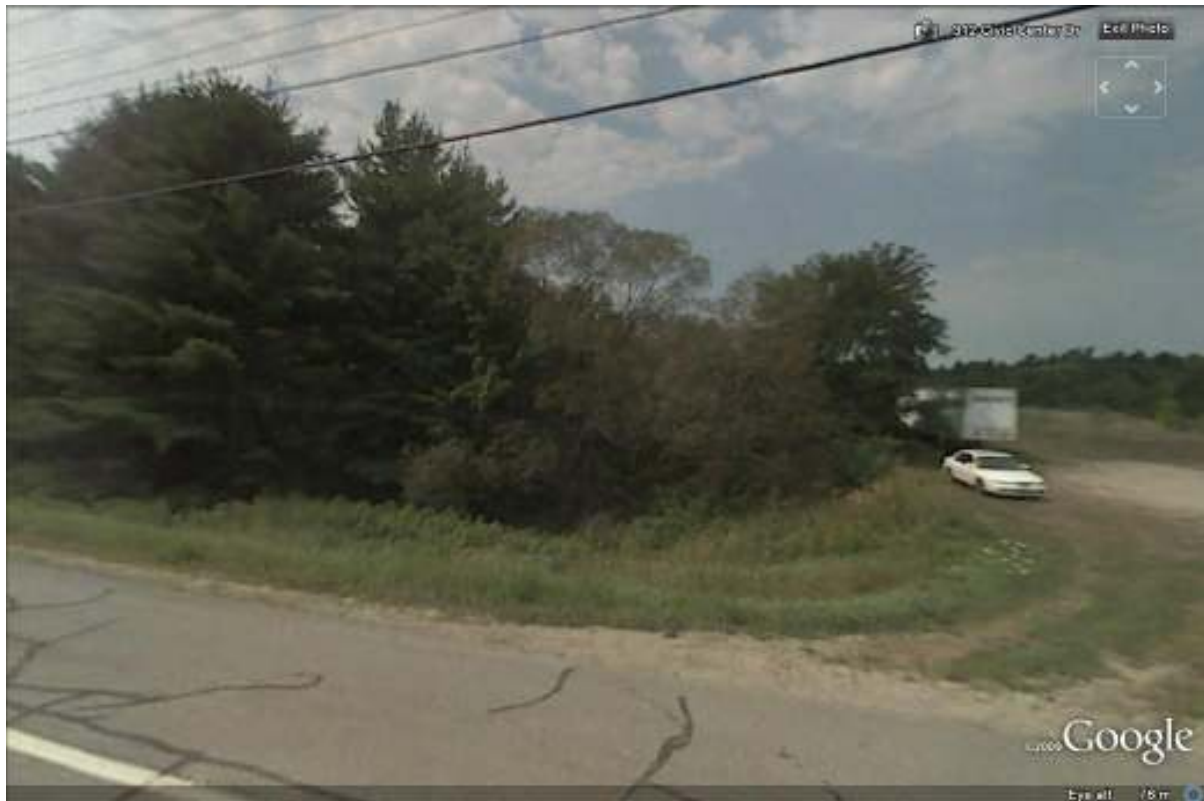
112-6

Functional assessment:													
1. Town: Augusta			2. Route: Exit 112-113 study- Old Belgrade RD				3. PIN: 17592.00						
4. Wetland ID: 112 – 6, 112-7			5. Cowardin Class: PSS				6. Stationing/Location:						
7. Dominant Vegetation: Willow, Cattail							8. Wetland Morphology: Drainage swale						
8a. NEIWPCC Soils Criteria: no samples taken													
9. Notes:													
10. FVA Table: impacted area													
F/V	GRD	FFA	AH	STR	NTR	PE	SSS	WH	REC	ESV	U/H	VQA	ES
Occurs		X		x									
Principal		X											
<p>Impacted area notes: The wetland collects surface run off from surrounding uplands. 112-4 and 112-5 are connected by a drainage culvert under Route 27. The wetlands also retain sediments from the adjacent Route 27.</p>													
11. Is this wetland part of larger complex: Yes

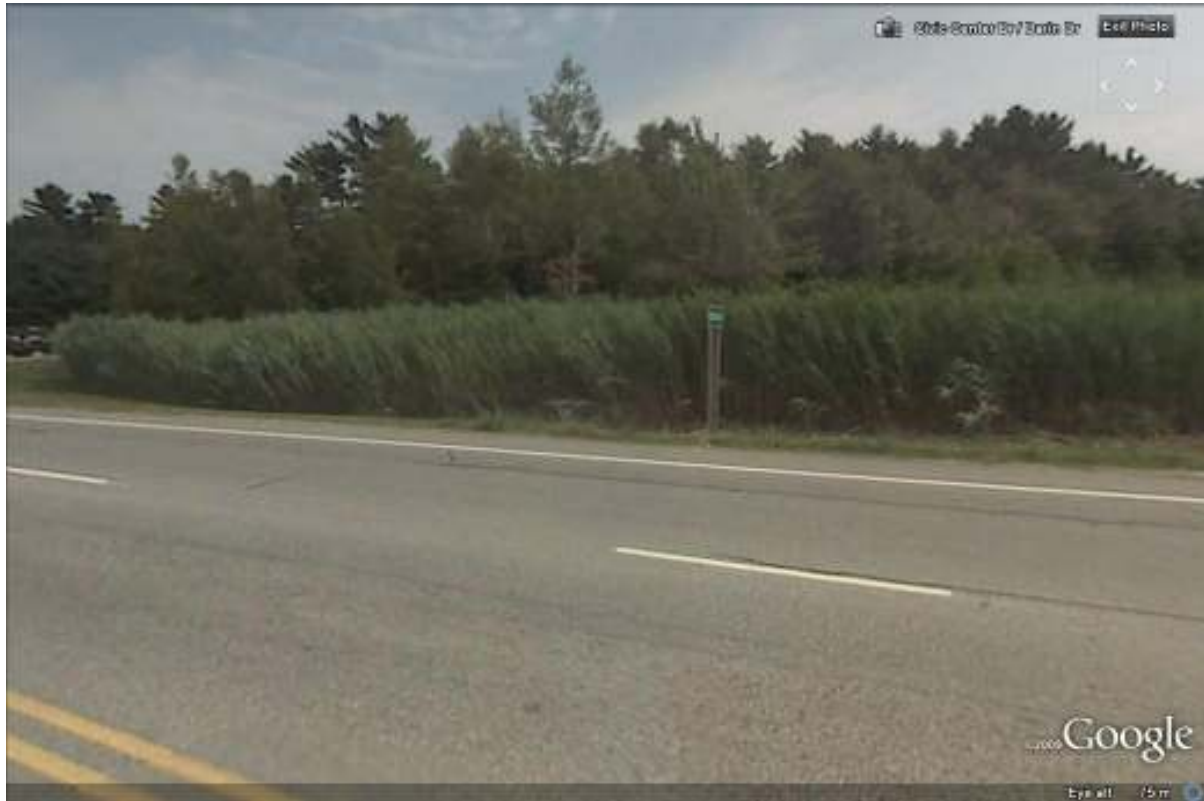
Functional assessment:													
1. Town: Augusta			2. Route: Exit 112-113 study- Old Belgrade RD				3. PIN: 17592.00						
4. Wetland ID: 112-8			5. Cowardin Class: PEM/SS				6. Stationing/Location:						
7. Dominant Vegetation: Phragmites-Alders							8. Wetland Morphology: Basin associated with a stream						
8a. NEIWPCC Soils Criteria: No soils taken													
9. Notes:													
10. FVA Table: impacted area													
F/V	GRD	FFA	AH	STR	NTR	PE	SSS	WH	REC	ESV	U/H	VQA	ES
Occurs				X									
Principal				X									
Impacted area notes: This wetland abuts Route 27 and flows into Stone Brook, It position helps to protect water quality in Stone Brook													
11. Is this wetland part of larger complex: yes 112-9 and 112-10

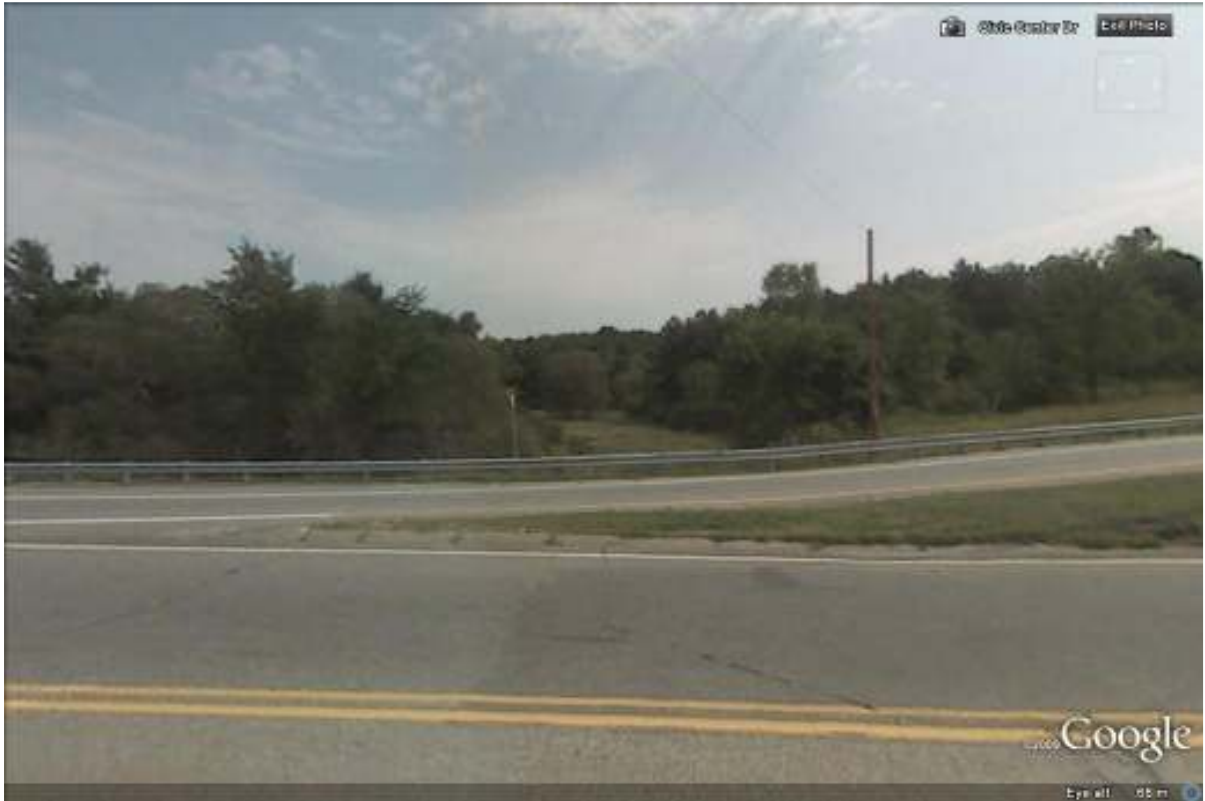
12. Impact Notes/Photos
112-9

Functional assessment:													
1. Town: Augusta			2. Route: Exit 112-113 study- Old Belgrade RD				3. PIN: 17592.00						
4. Wetland ID: 112- 9 112-10			5. Cowardin Class: PEM/SS/RUS				6. Stationing/Location:						
7. Dominant Vegetation: Bulrushes, grasses and Willow							8. Wetland Morphology: Wetland floodway associated with a stream						
8a. NEIWPCC Soils Criteria: No soils taken													
9. Notes: Not reviewed in field													
10. FVA Table: impacted area													
F/V	GRD	FFA	AH	STR	NTR	PE	SSS	WH	REC	ESV	U/H	VQA	ES
Occurs		X	X					X					
Principal		X	X										
<p>Impacted area notes: Area has slow moving water and a floodplain wetland. Flooding function is enhanced by the culvert . The stream is known to have fish and other aquatic organisms</p> <p>Whole wetland notes:</p>													
11. Is this wetland part of larger complex: Yes

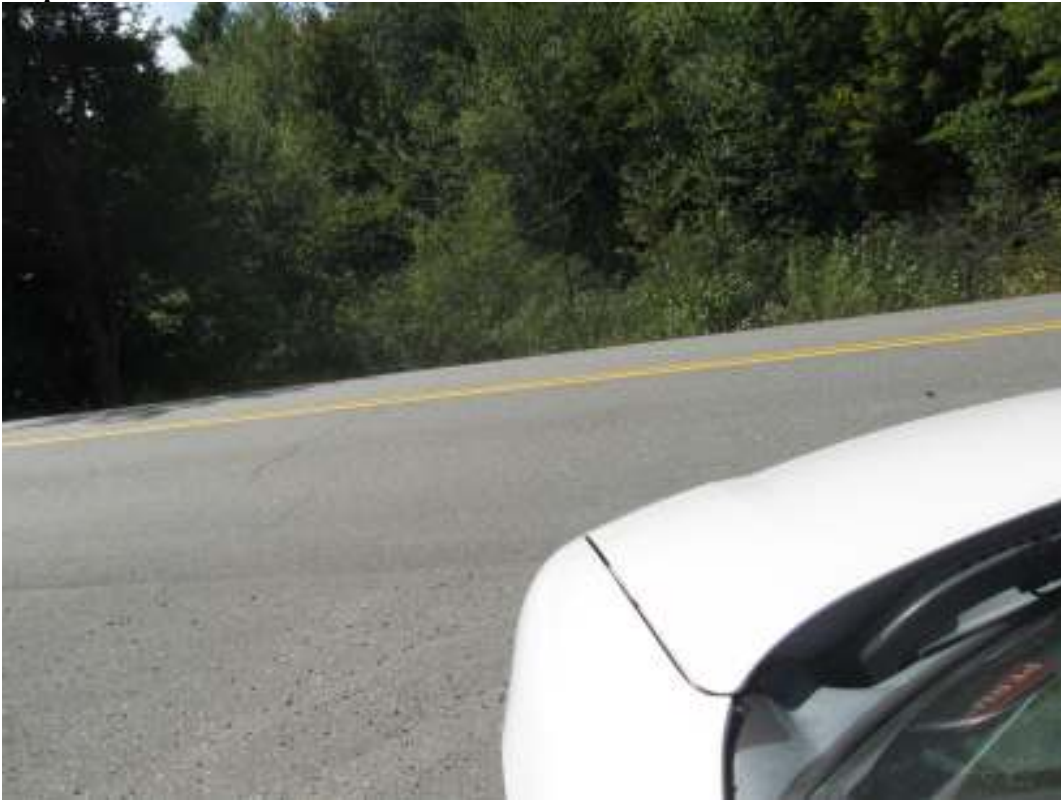
Functional assessment:													
1. Town: Augusta	2. Route: Exit 112-113 study- Old Belgrade RD	3. PIN: 17592.00											
4. Wetland ID: 113-1; 113-2	5. Cowardin Class: PFO	6. Stationing/Location:											
7. Dominant Vegetation: Ash, cedars, alders, winterberry								8. Wetland Morphology: Sloping wetland adjacent to road- 113-1 is down-gradient from Road, 113-2 is up-gradient					
8a. NEIWPC Criteria: No soils take at this point													
9. Notes: Planning level review													
10. FVA Table: impacted area													
F/V	GRD	FFA	AH	STR	NTR	PE	SSS	WL	REC	ESV	U/H	VQA	ES
Occurs													
Principal								X					
<p>Impacted area notes: The area functions as wildlife habitat as it is part of an upland habitat block that is use for disturbance tolerant species</p> <p>Whole wetland notes:</p>													
11. Is this wetland part of larger complex: NO

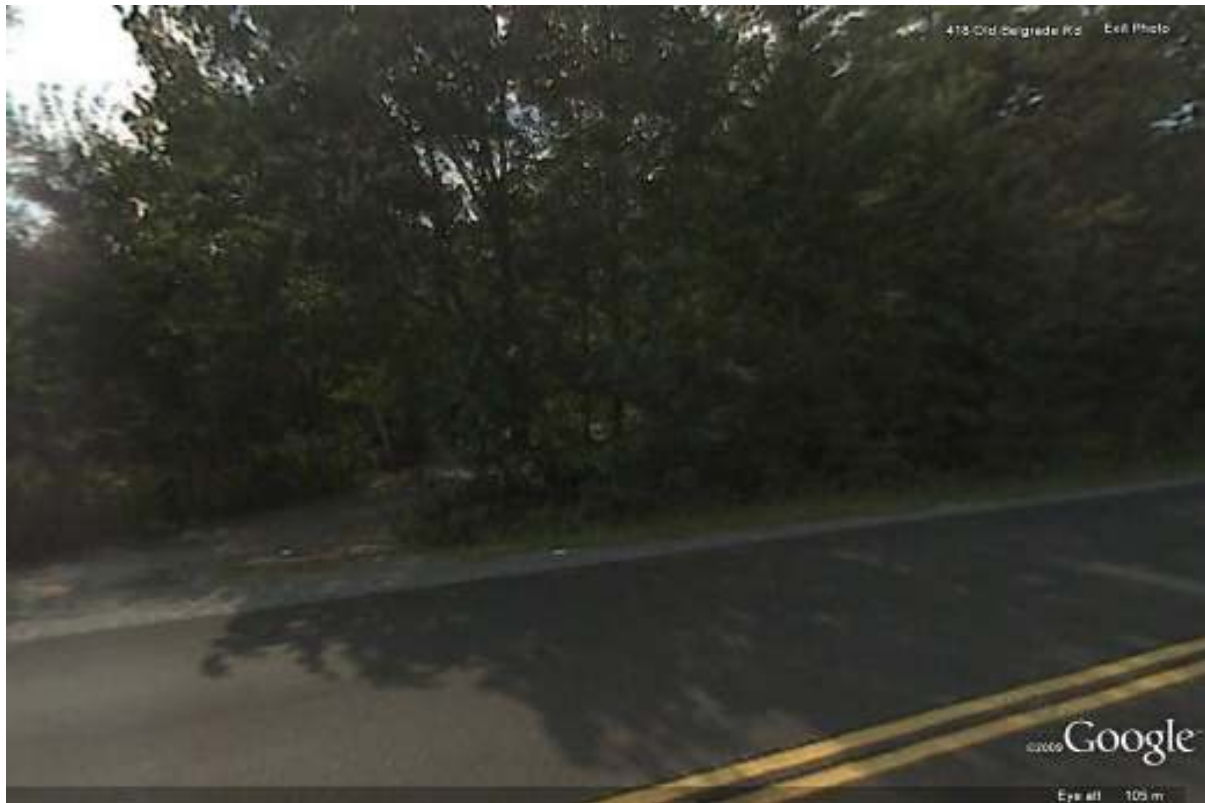
12. Impact Notes/Photos
113-3

Functional assessment:													
1. Town: Augusta			2. Route: Exit 112-113 study- Old Belgrade RD				3. PIN: 17592.00						
4. Wetland ID: 113-3,113-4			5. Cowardin Class: PFO				6. Stationing/Location:						
7. Dominant Vegetation: Ash, cedars, alders, winterberry							8. Wetland Morphology: basin created by highway						
8a. NEIWPCC Soils Criteria: no soils data taken													
9. Notes: Small pockets													
10. FVA Table: impacted area													
F/V	GRD	FFA	AH	STR	NTR	PE	SSS	WH	REC	ESV	U/H	VQA	ES
Occurs													
Principal													
<p>Impacted area notes: These area are small and due to the small size, have to appreciable function</p> <p>Whole wetland notes:</p>													
11. Is this wetland part of larger complex: no

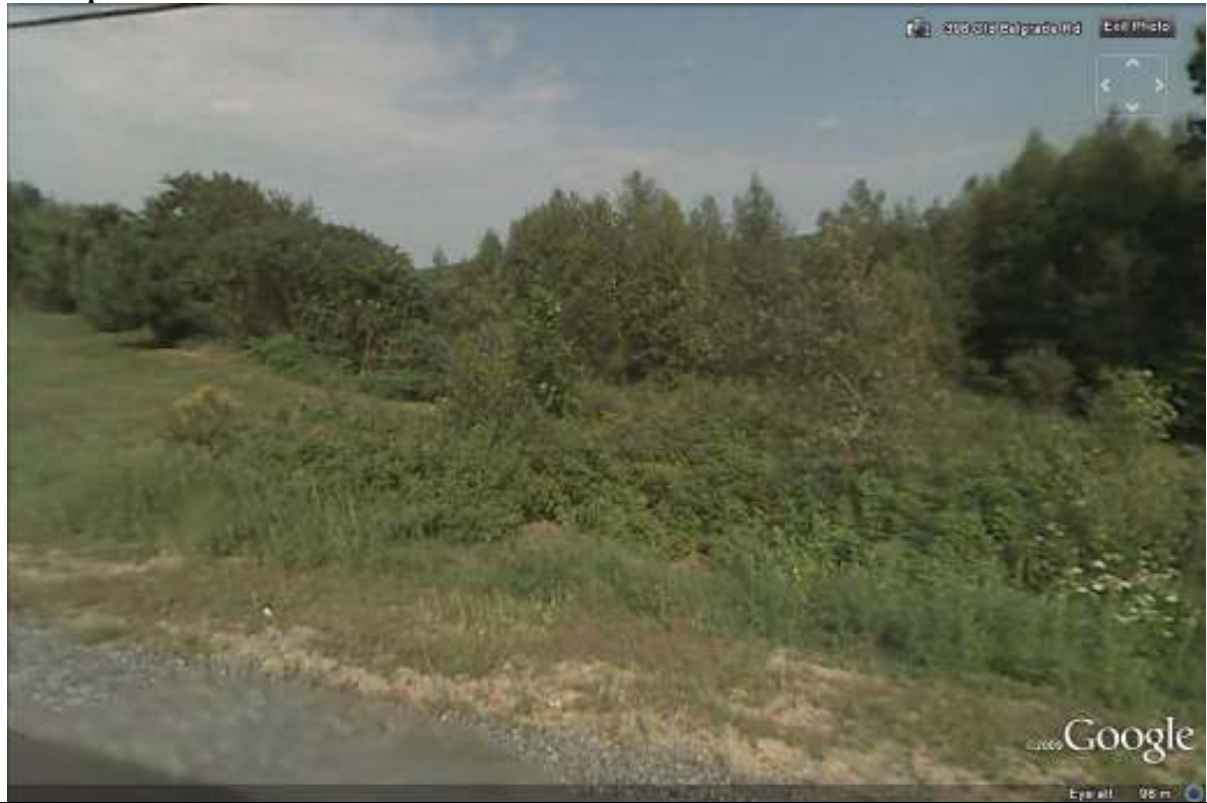
1. Town: Augusta	2. Route: Exit 112-113 study- Old Belgrade RD	3. PIN: 17592.00											
4. Wetland ID: 113-5	5. Cowardin Class: PSS	6. Stationing/Location:											
7. Dominant Vegetation: Alders, Cattail, bulrush, sedges		8. Wetland Morphology: Discharging slope											
8a. NEIWPCC Soils Criteria: None													
9. Notes: Area is discharging slope that keeps a small basin and slope wetland wet. There is a compacted trail that crosses the wetland													
10. FVA Table: impacted area													
	GRD	FFA	AH	STR	NTR	PE	SSS	WH	REC	ESV	U/H	VQA	ES
Occurs	X							X					
Principal	X												
Impacted area notes:													
Whole wetland notes:

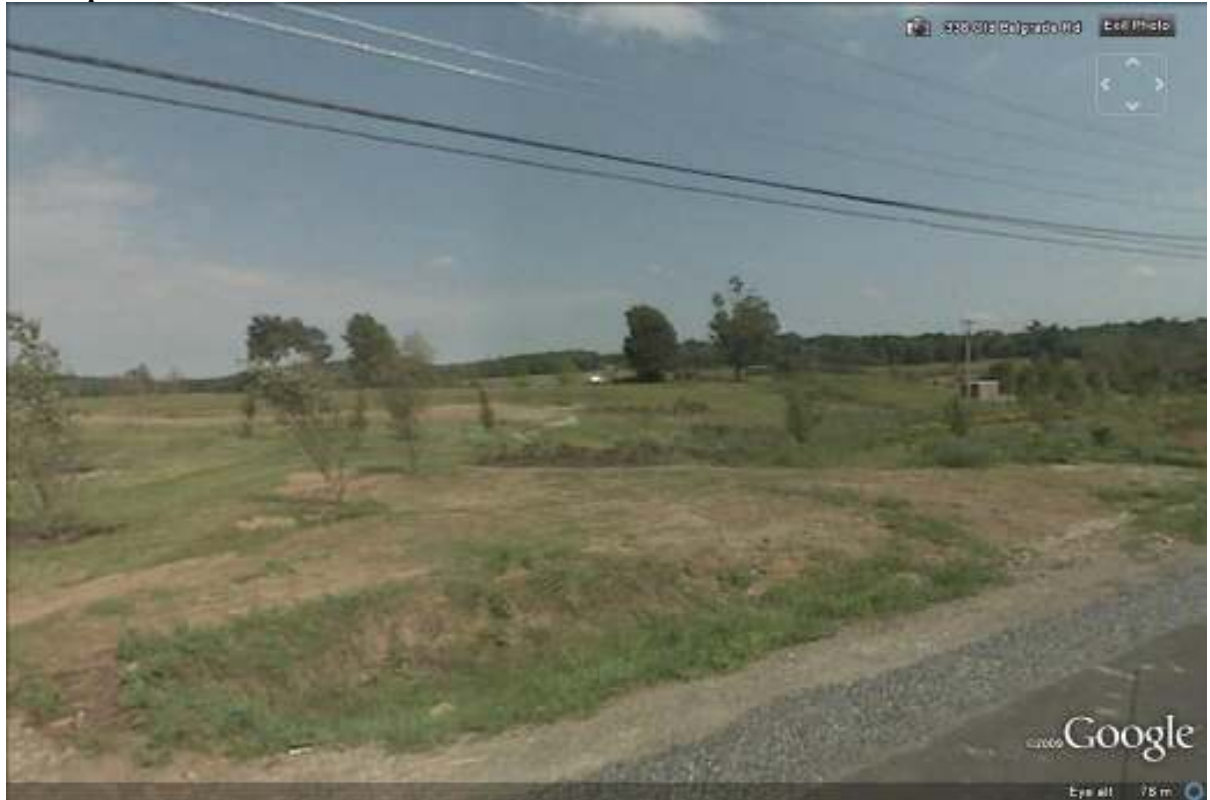
1. Town: Augusta	2. Route: Exit 112-113 study- Old Belgrade RD	3. PIN: 17592.00											
4. Wetland ID: 113-6	5. Cowardin Class: PEM	6. Stationing/Location:											
7. Dominant Vegetation: Cattail, Sedges, Phalaris		8. Wetland Morphology: Sloping basin											
8a. NEIWPCC Soils Criteria: None													
9. Notes: This is a drainage swale													
10. FVA Table: impacted area													
F/V	GRD	FFA	AH	STR	NTR	PE	SSS	WH	REC	ESV	U/H	VQA	ES
Occurs	x												
Principal				X									
<p>Impacted area notes: This area is a swale that collects surface run off. This was a bigger function when the area was a farm. It is now adjacent to the Cancer Center Parking lot. It is also at the base of slopes and hillside, so some groundwater discharging occurs</p> <p>Whole wetland notes:</p>

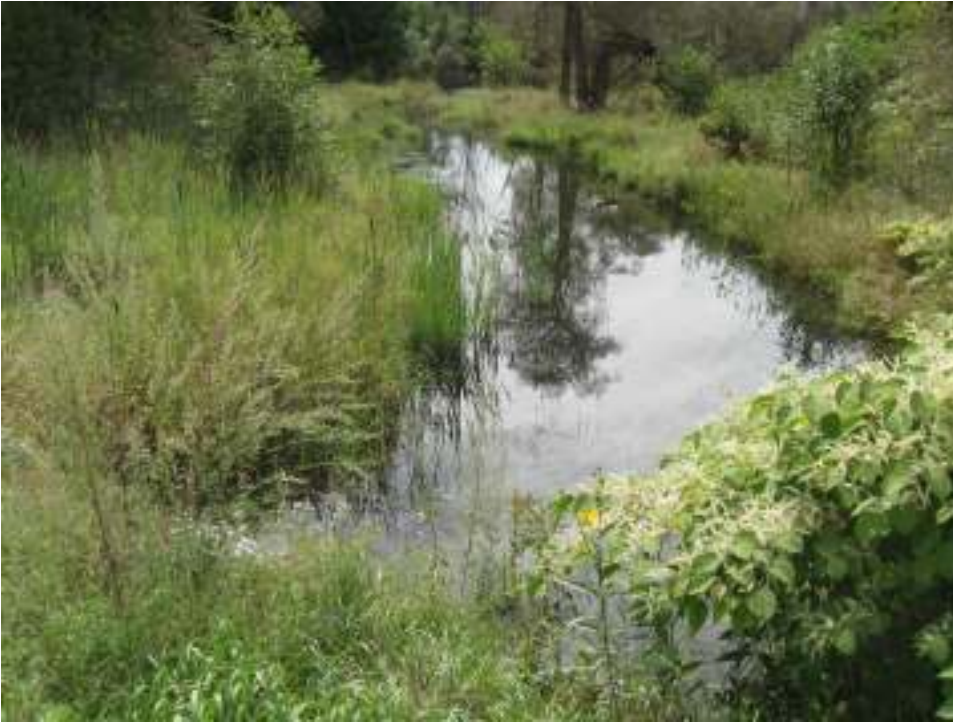
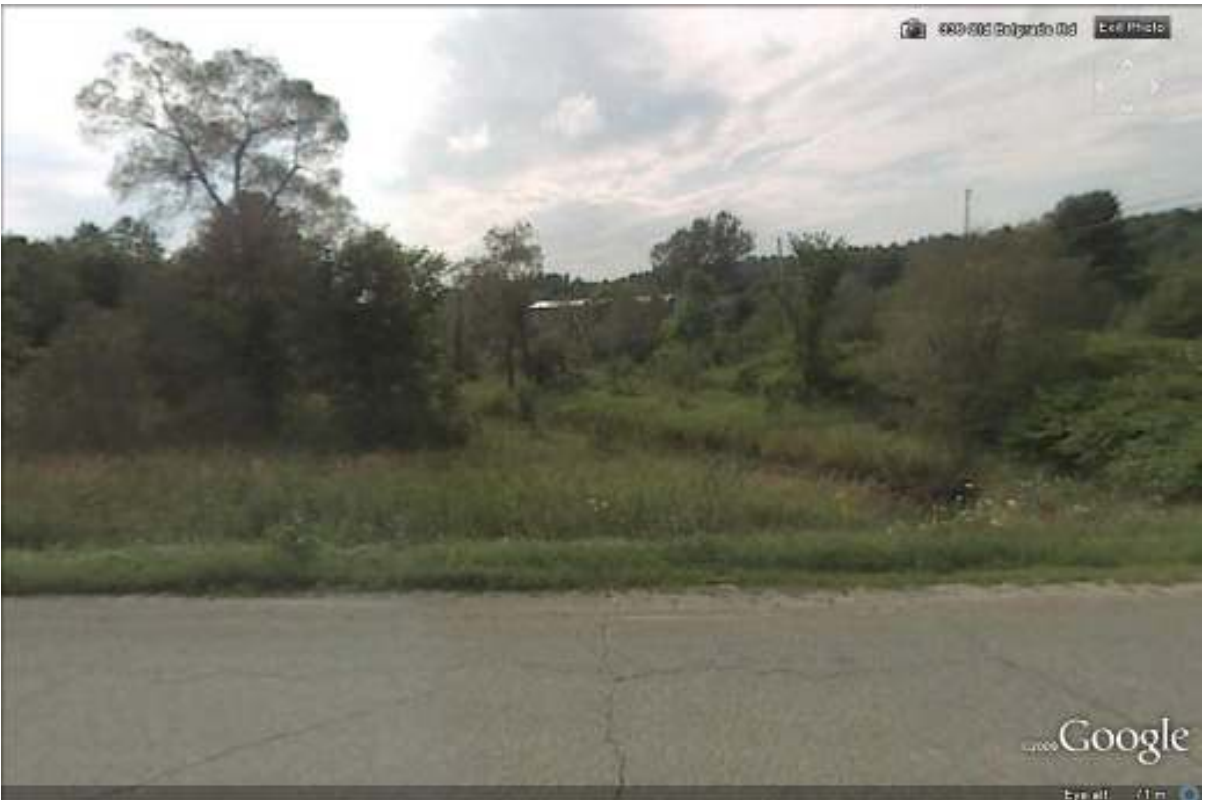
12. Impact Notes/Photos
Downstream

7. Dominant Vegetation: PSS- Alders, Viburnum- PEM Cattail- sedges						8. Wetland Morphology: Stream associated- slow moving low gradient stream system							
8a. NEIWPCC Soils Criteria: None

9. Notes:													
10. FVA Table: impacted area													
F/V	GRD	FFA	AH	STR	NTR	PE	SSS	WH	REC	ESV	U/H	VQA	ES
Occurs													
Principal		X	X										
<p>Impacted area notes: This is a slow moving- mostly impounded stream segment. This has a broad flooded floodway, with some remaining storage. Stone Brook drains southeasterly away from the Old Belgrade Road crossing toward Bond Brook. This area stores rains and melt water, and also acts as habitat for herptile and other water dependant species</p> <p>Whole wetland notes:</p>

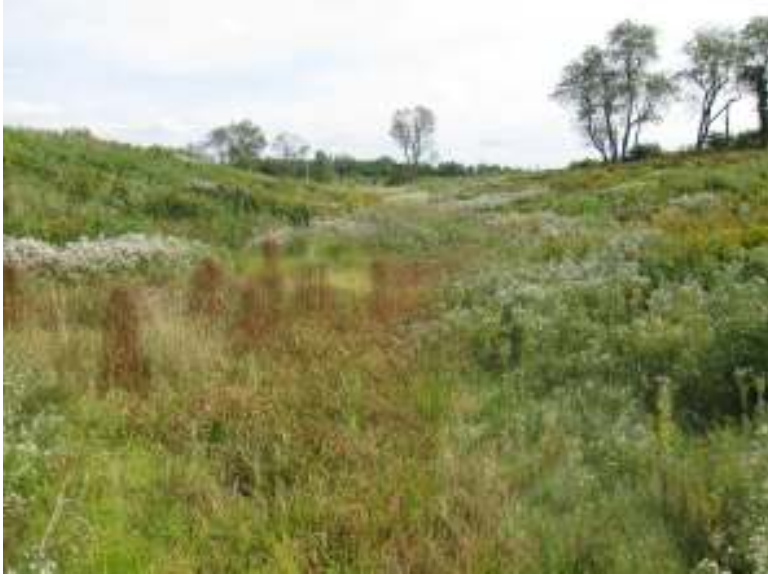
Functional assessment:													
1. Town: Augusta		2. Route: Exit 112-113 study- Old Belgrade RD				3. PIN: 17592.00							
4. Wetland ID: 113-10 113-11		5. Cowardin Class: PEM				6. Stationing/Location:							
7. Dominant Vegetation: Scirpus sp, cattail						8. Wetland Morphology: Drainage way							
8a. NEIWPCC Soils Criteria: None taken													
9. Notes: This is a drainage swale though low topography. This collects overland flows and desynchronizes flood flows													
10. FVA Table: impacted area													
F/V	GRD	FFA	AH	STR	NTR	PE	SSS	WH	REC	ESV	U/H	VQA	ES
Occurs													
Principal		X											
Impacted area notes:													
Whole wetland notes:													
11. Is this wetland part of larger complex: yes, this flows into the Stone brook wetland complex													
12. Impact Notes/Photos

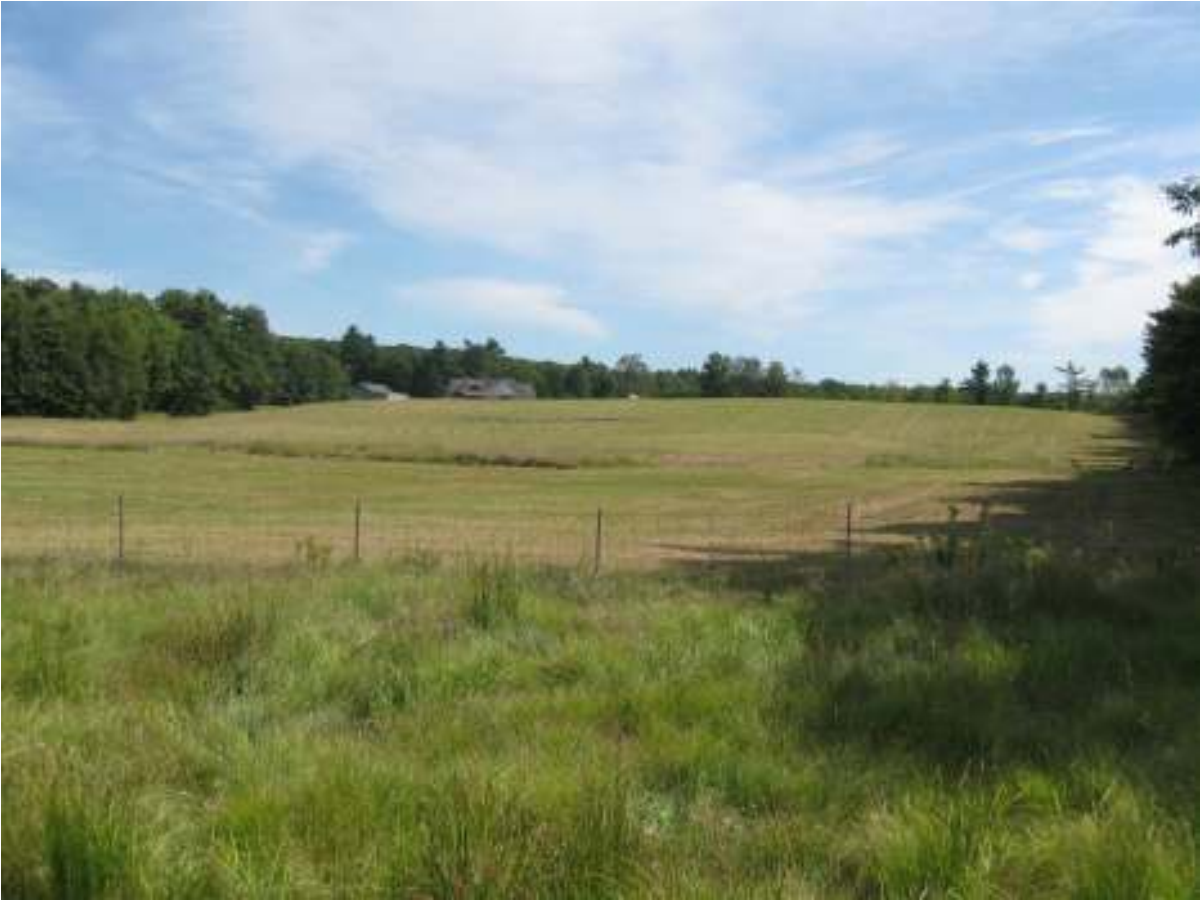
Overview

9. Notes: These areas are in a mown field. They are low points that collect water surface and groundwater- There was evidence of amphibian breeding but ponded water was shallow and there was no evidence of sufficient hydro-period.

10. FVA Table: impacted area 113-23 only. The rest are too small													
F/V	GRD	FFA	AH	STR	NTR	PE	SSS	WH	REC	ESV	U/H	VQA	ES
Occurs	x					x		x					
Principal						X							
Impacted area notes: These areas are mown, so that they export food out of the wetland by human action													
Whole wetland notes:

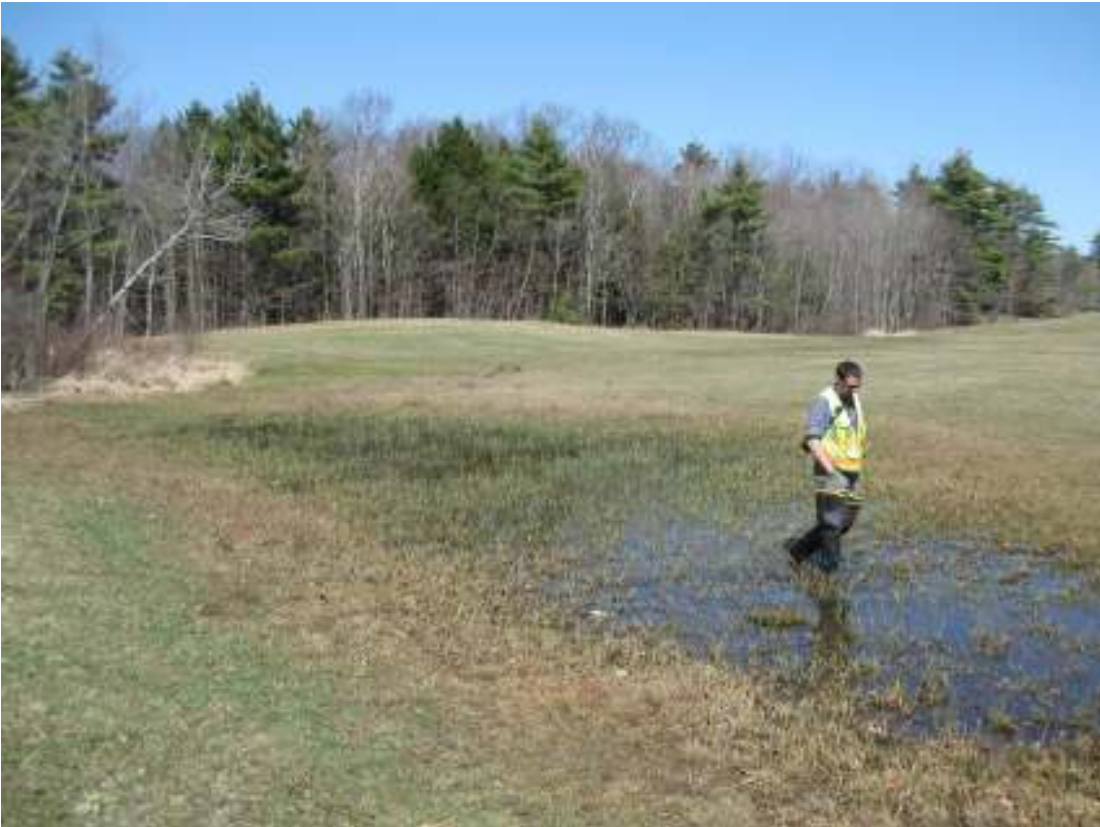
Wetland 113-23

There were a high number of woodfrog eggmasses, found in Wetland 113-23. This was a shallow drainage depression in a field. The water depth and morphology at the site indicated that the water dries up in a short period of time and that the hydroperiod was insufficient to accommodate successful amphibian breeding. This pool was dried by the middle of May. Currently, no alignment will affect these vernal pools or a 500 foot dispersal habitat area around it.

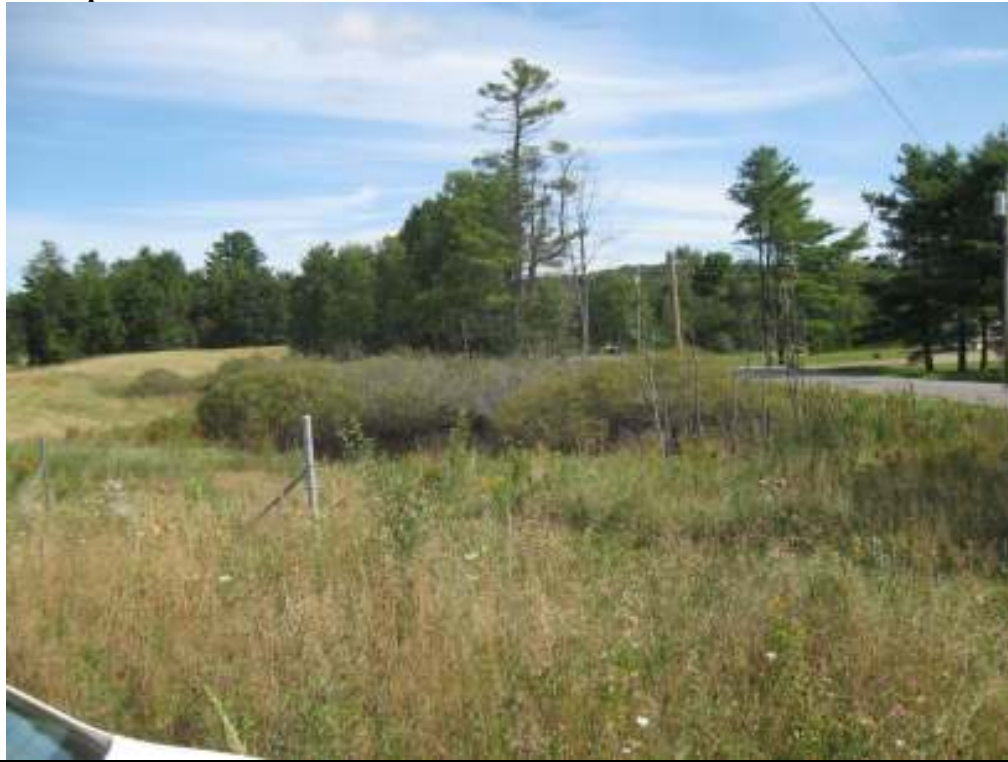
1. Town: Augusta	2. Route: Exit 112-113 study- Old Belgrade RD	3. PIN: 17592.00											
4. Wetland ID: 113-25	5. Cowardin Class: PEM/LUS	6. Stationing/Location:											
7. Dominant Vegetation: Reed Canary Grass- Bulrushes.		8. Wetland Morphology: This is a drainage swale that drains into a ponded area adjacent to Eight Rod Road											
8a. NEIWPCC Soils Criteria:													
9. Notes:													
10. FVA Table: impacted area													
F/V	GRD	FFA	AH	STR	NTR	PE	SSS	WH	REC	ESV	U/H	VQA	ES
Occurs	x	x											
Principal		X											
<p>Impacted area notes: This area captures run off and small amounts of groundwater discharge and carries it to a ponded area.</p> <p>Whole wetland notes:</p>

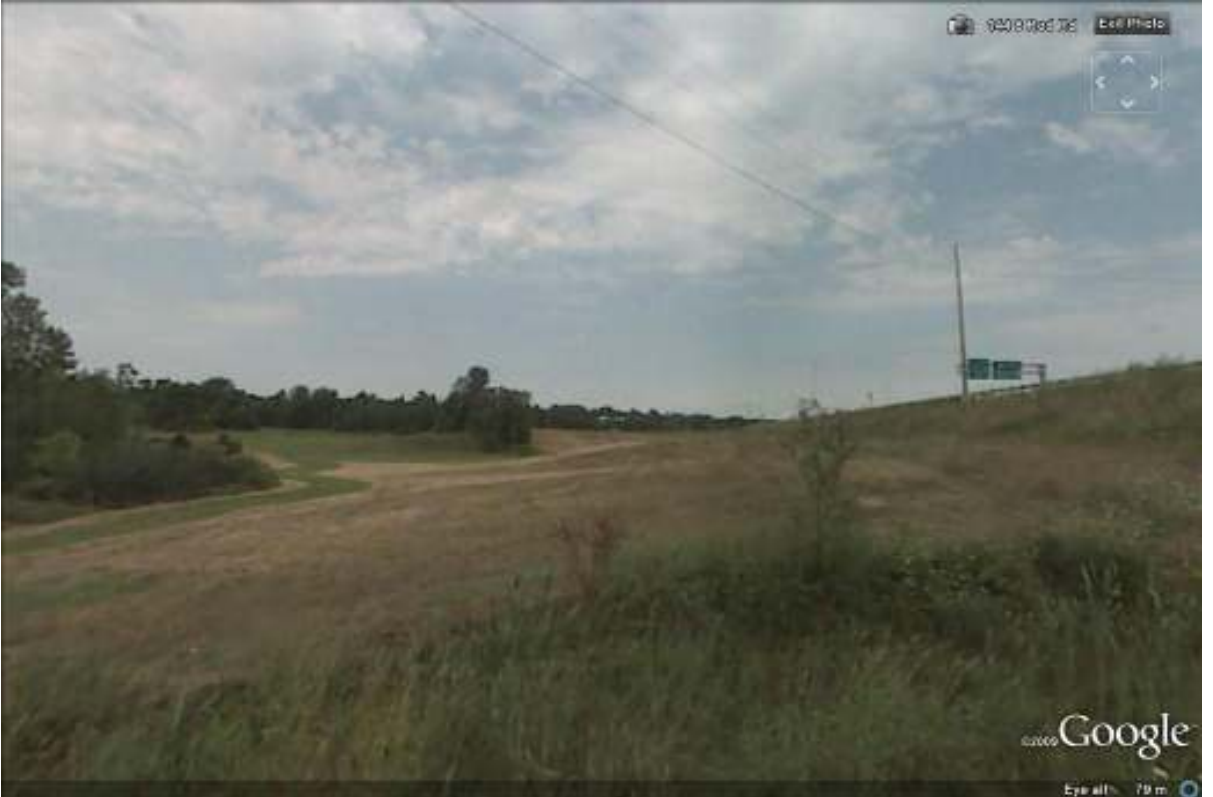
Functional assessment:													
1. Town: Augusta		2. Route: Exit 112-113 study- Old Belgrade RD				3. PIN: 17592.00							
4. Wetland ID: 113-26		5. Cowardin Class: Sedges/ Reed canary Grass				6. Stationing/Location:							
7. Dominant Vegetation:						8. Wetland Morphology: Discharging slope							
8a. NEIWPCC Soils Criteria: No data													
9. Notes:													
10. FVA Table: impacted area													
F/V	GRD	FFA	AH	STR	NTR	PE	SSS	WH	REC	ESV	U/H	VQA	ES
Occurs	X			X	X								
Principal					X								
Impacted area notes: This area captures the run off and sediments from the adjacent highway													
Whole wetland notes:													
11. Is this wetland part of larger complex: Yes													
12. Impact Notes/Photos

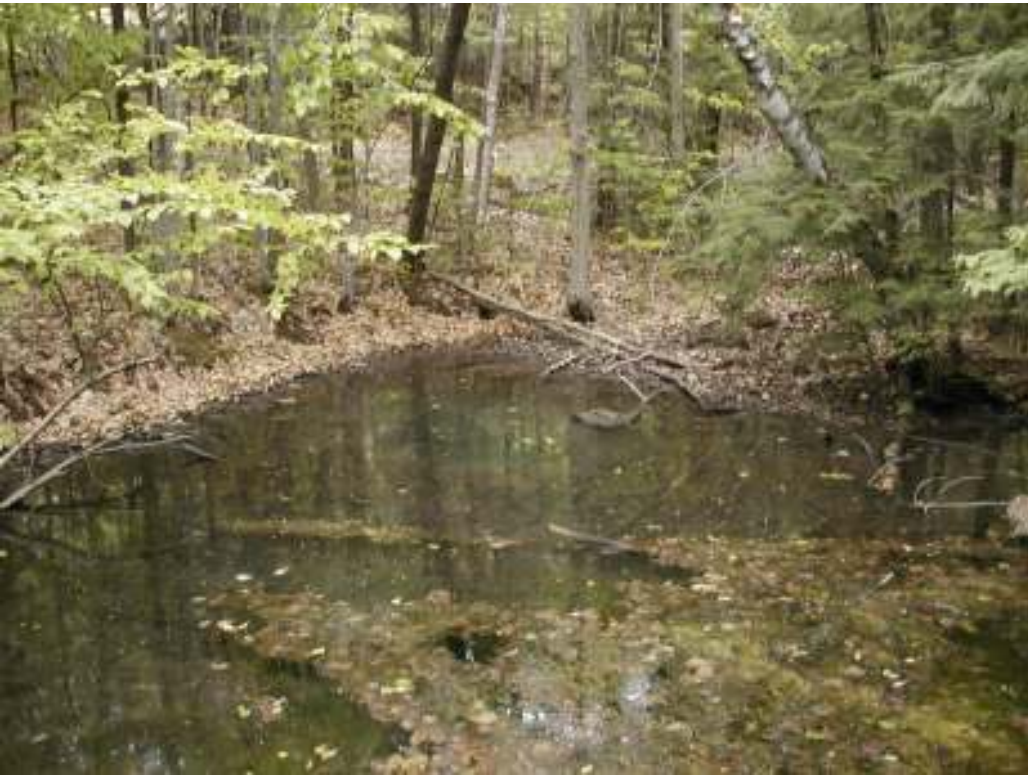
There was also evidence of amphibian breeding in pools in Wetlands Conn-1 and Conn-2. These had less than significant numbers of wood frogs eggmasses and appeared to

Functional assessment:													
1. Town: Augusta			2. Route: Exit 112-113 study- Old Belgrade RD				3. PIN: 17592.00						
4. Wetland ID: Conn-1, Conn-2			5. Cowardin Class: PSS/UB				6. Stationing/Location:						
7. Dominant Vegetation: Grasses, alders, willows							8. Wetland Morphology: Basin						
8a. NEIWPCC Soils Criteria: No soils taken													
9. Notes:													
10. FVA Table: impacted area													
F/V	GRD	FFA	AH	STR	NTR	PE	SSS	WH	REC	ESV	U/H	VQA	ES
Occurs	X	X						X					
Principal	X												
<p>Impacted area notes: This area is fed by groundwater that pools up in an artificial pool. Amphibians are found in the pool</p> <p>Whole wetland notes:</p>													
11. Is this wetland part of larger complex:													
12. Impact Notes/Photos

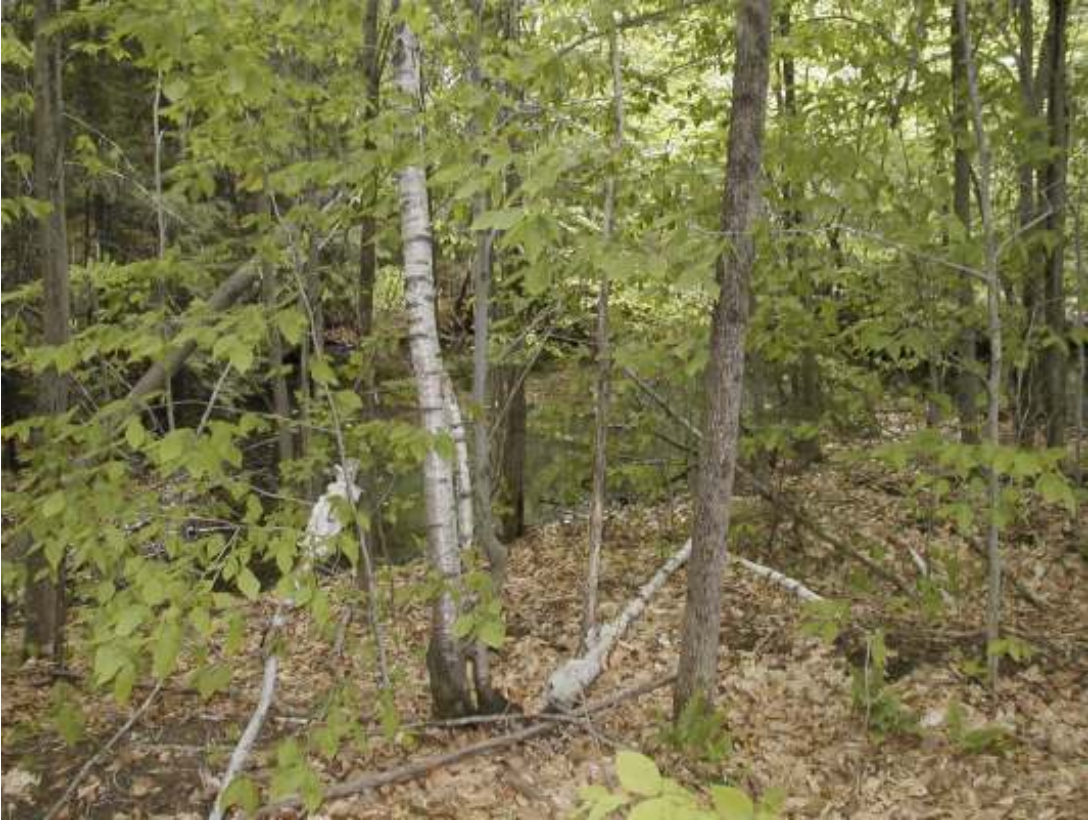
There is a vernal pool in Wetland Conn-3. (Figure 4 Habitat Map) This is a large, natural pool that is fed by snow melt water and some ground water discharge. This has an upland overstory and a shrub understory of alders and winterberry. This pool had 50 wood frog eggmasses and 12 Spotted Salamander Eggmasses in Spring of 2009. This would be a Significant Vernal Pool under MDEP regulations.

Functional assessment:													
1. Town: Augusta			2. Route: Exit 112-113 study- Old Belgrade RD				3. PIN: 17592.00						
4. Wetland ID: Conn-3			5. Cowardin Class: PSS/UB				6. Stationing/Location:						
7. Dominant Vegetation: Winterberry, Alders			8. Wetland Morphology: Basin Morphology										
8a. NEIWPCC Soils Criteria: No soils taken													
9. Notes: This appears to be a natural vernal pool with significant numbers of Spotted salamanders and Woodfrogs 12 Eggmasses and 50 eggmasses respectively													
10. FVA Table: impacted area													
F/V	GRD	FFA	AH	STR	NTR	PE	SSS	WH	REC	ESV	U/H	VQA	ES
Occurs	X							X					
Principal								X					
Impacted area notes:													
11. Is this wetland part of larger complex:													
12. Impact Notes/Photos
